# HeriTACE

## Building envelope characteristics

Deliverable D2.1

| Project Title | Future-proofing Heritage Townhouses by Optimising Comfort and Energy in Time and Space |

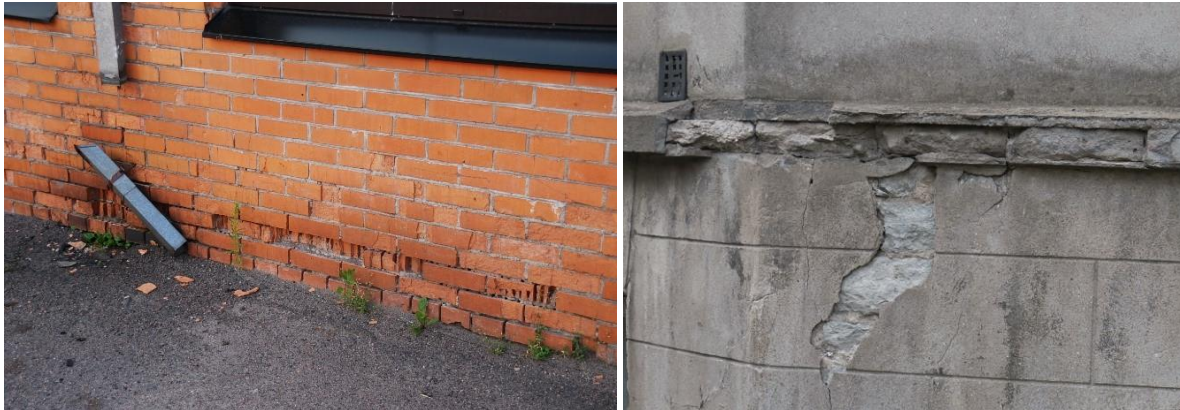
Figure 3-1: Left: frost damage in the plinth area of a brick wall. The bricks lack adequate frost resistance, making them unsuitable for use in plinth areas exposed to freeze-thaw cycles in cold climates (photo: Targo Kalamees). Right: damaged water flashing on top of plinth has led to frost damage of underlying lime-sand bricks and plaster below (photo: Paul Klõšeiko).

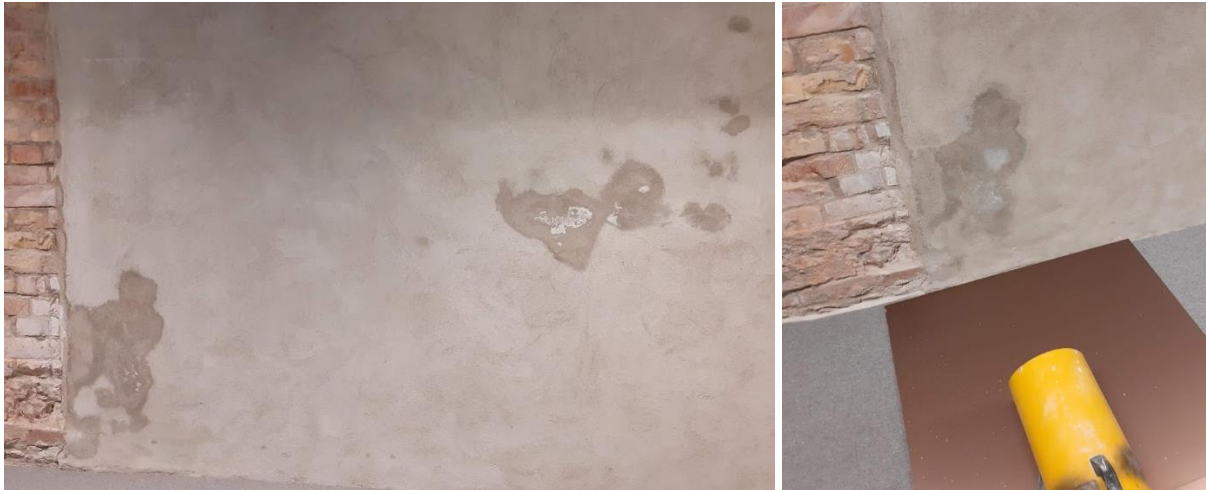
Figure 3-2: salt efflorescence appearing on damp areas of a masonry wall finished with cement-lime plaster after renovation (left). The moisture source was precipitation that infiltrated the masonry cavities during the renovation process. Drying was accelerated using localised heating to halt further salt migration (right). Photos by Martin Talvik.

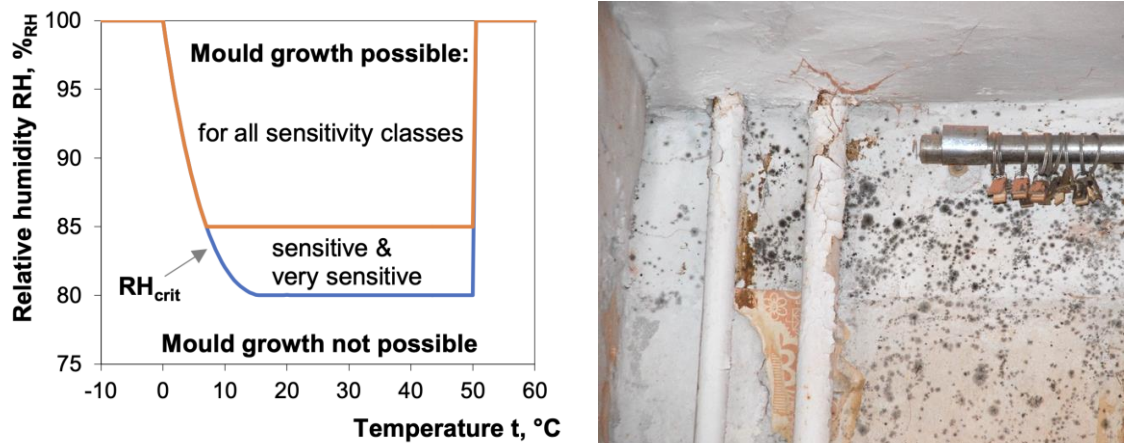
Figure 3-3: Left: favourable conditions for mould growth based on Viitanen et al. (2011). Right: mould growth on interior surface (a window-wall-ceiling-partition wall intersection of a masonry wall; schematic & photo: Paul Klõšeiko).

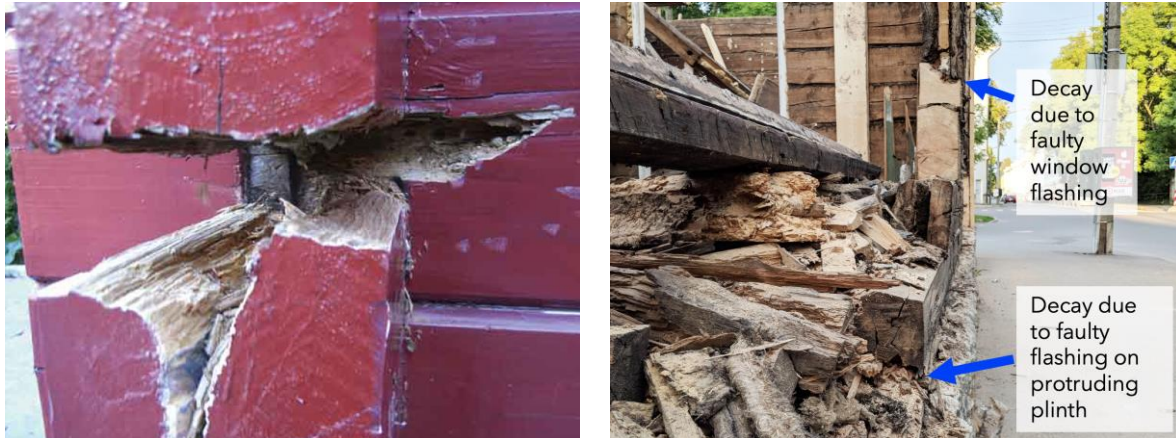
Figure 3-4: Left: rot damage at the notch joints in a log wall (photo: Sverre Holøs, SINTEF 720.082, 2007). Right: rot damage of logs behind ventilated cladding, caused by faulty flashings (photo: Paul Klößeiko).

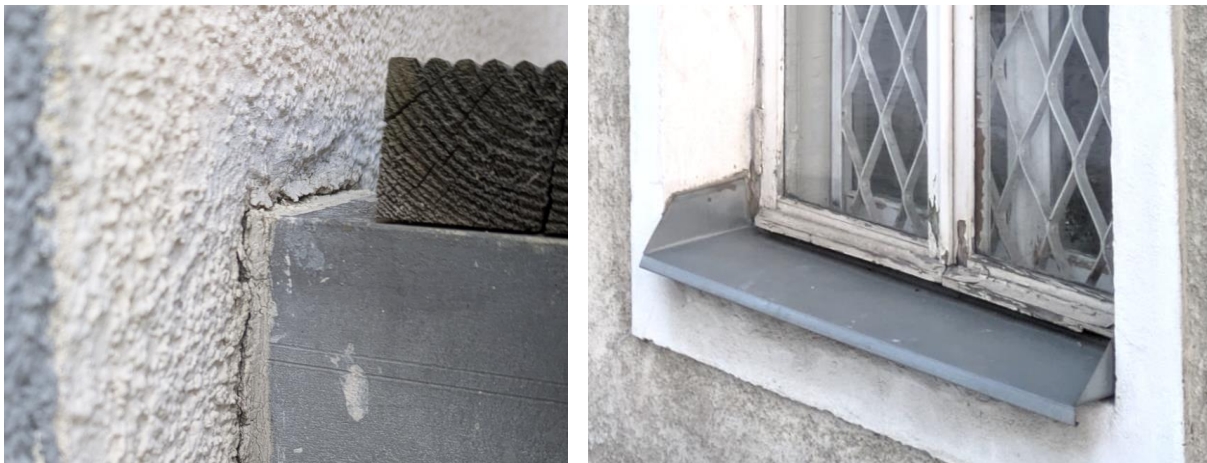
Figure 3-6: Sealant is damaged by UV radiation and differential deformations (left). Shrinkage and swelling of the wooden window frame has contributed to degradation of the paint layer (right).

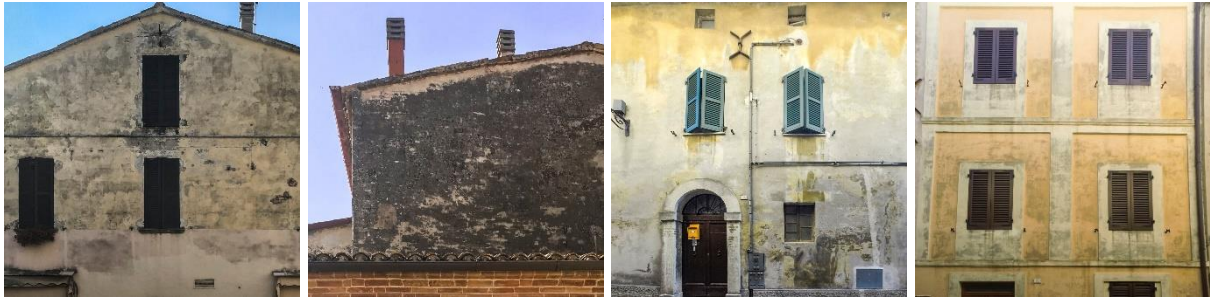
Figure 3-7: Examples of algae growth on external walls: (left two) façades exposed to wind driven rain; (right two) fed by drain water from windows overhangs  
(Blumberga and de Place Hansen, 2020 and <https://www.ribuild.eu/algae-growth>)

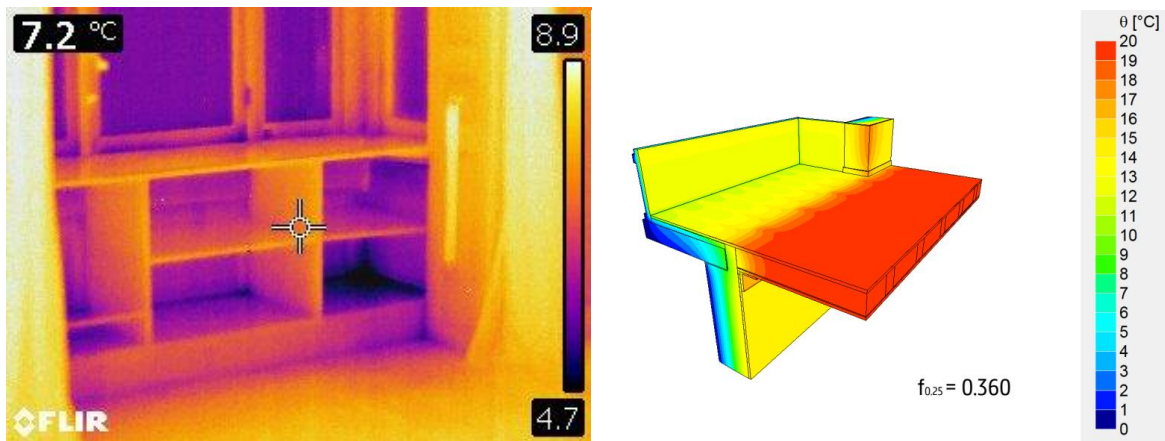
Figure 4-4: Thermographic image (left) and isotherms (right) of the lower part of a bay window.

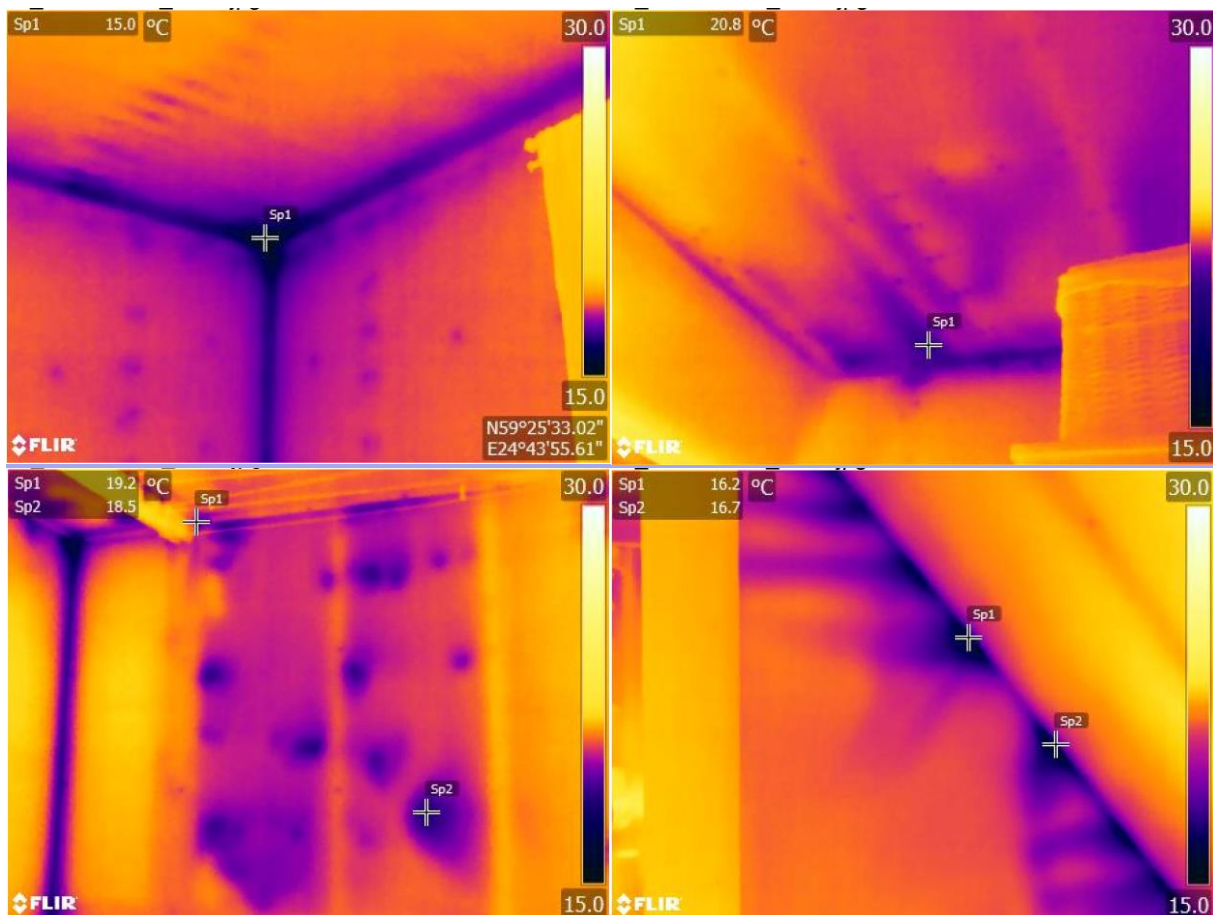
Figure 6-2: Illustrative examples of typical air leakage locations detected with thermography under blower door depressurization.

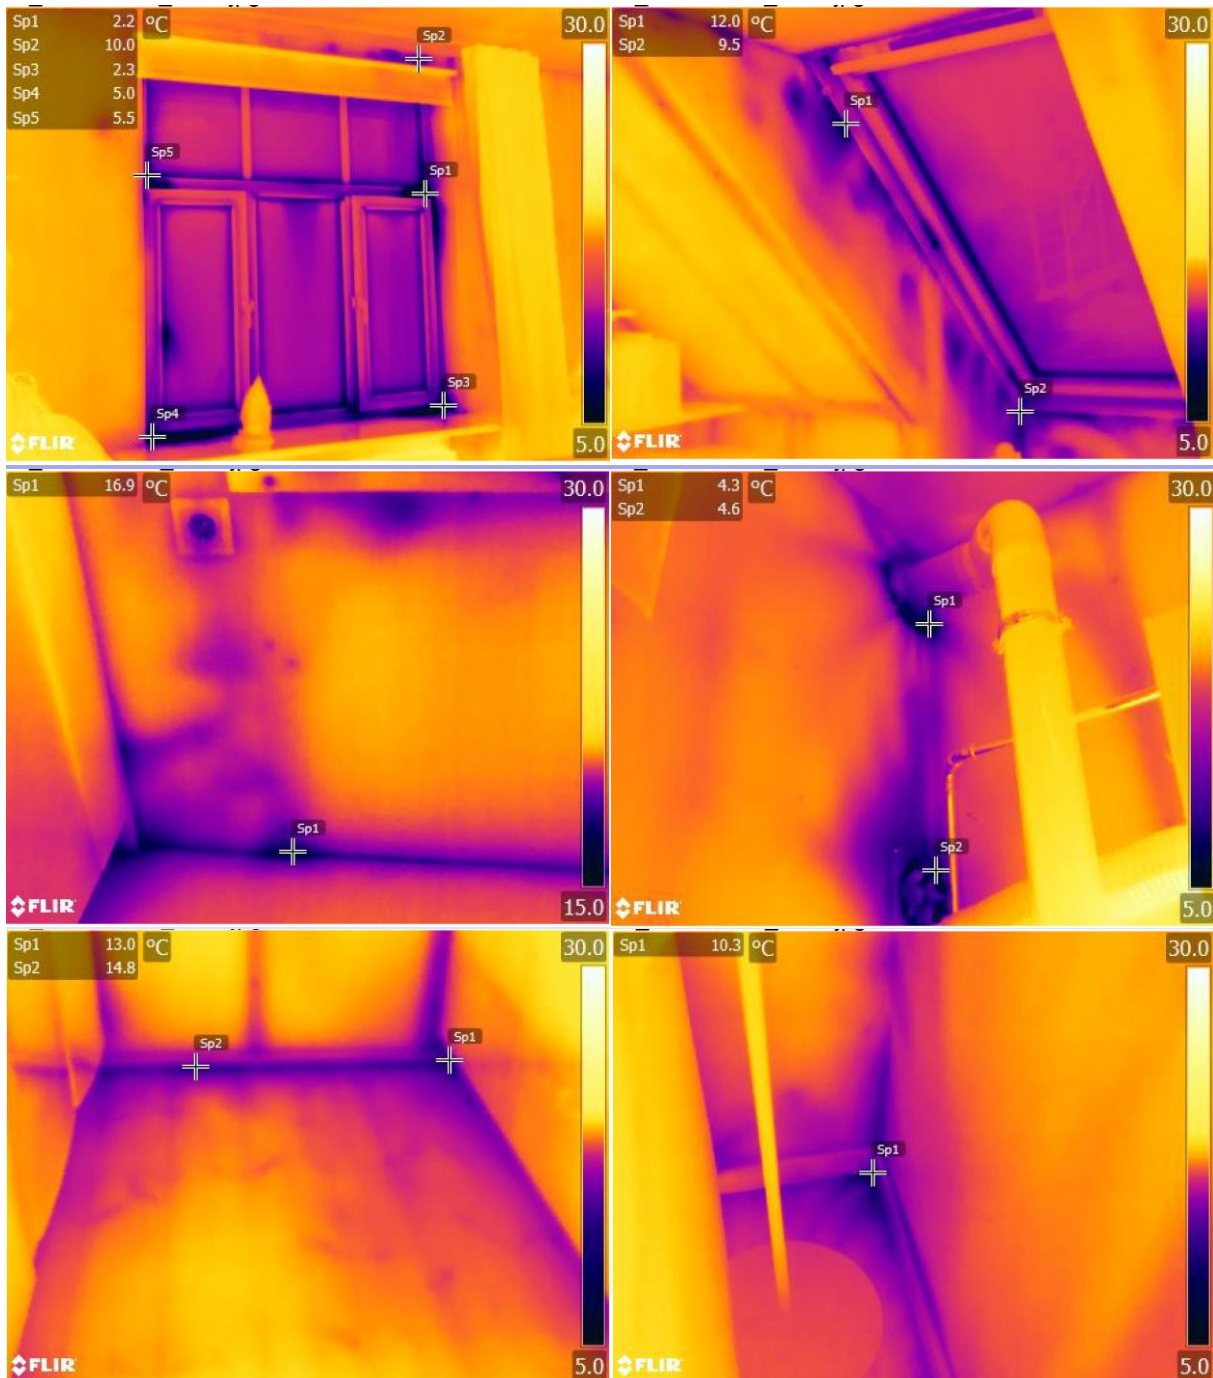
Figure 6-3: Illustrative examples of typical air leakage locations detected with thermography under blower door depressurization.

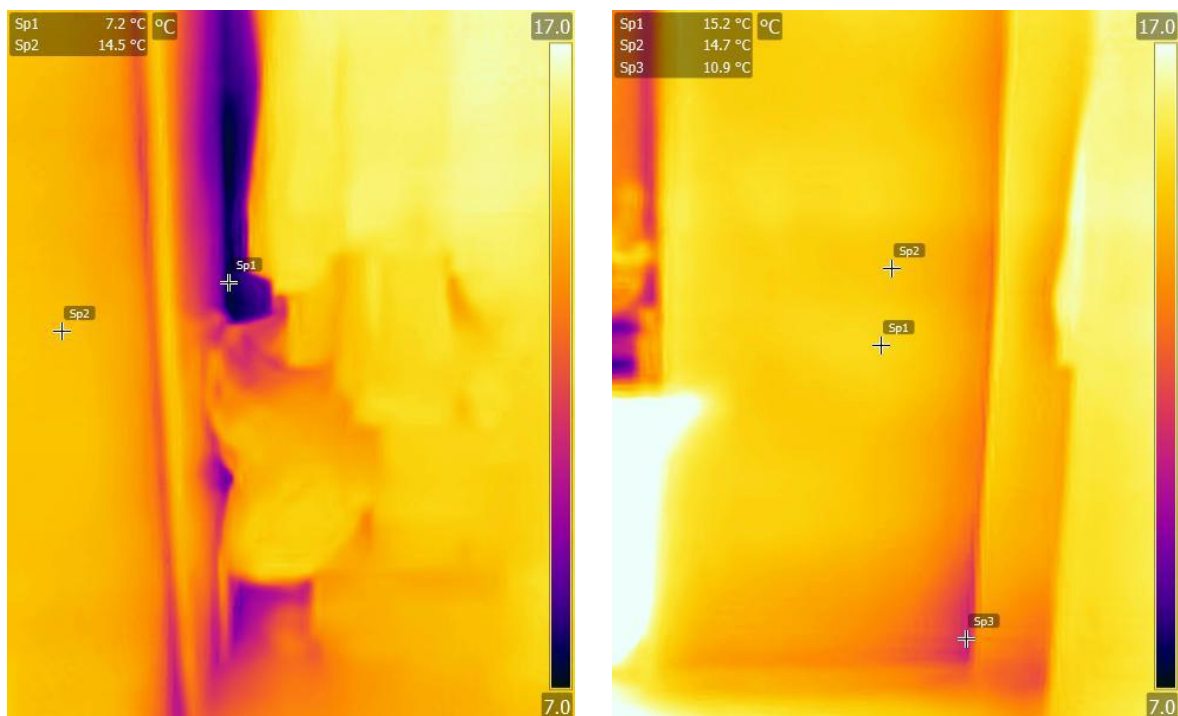
Figure 6-4: Problematic corner detail of a mass masonry wall studied in HeriTACE project. Sp1 of left thermogram shows surface temperature of the corner that also happens to be behind a cupboard resulting in a very low temperature factor of  $f_{Rsi} = 0.34$  and recurring mould growth.

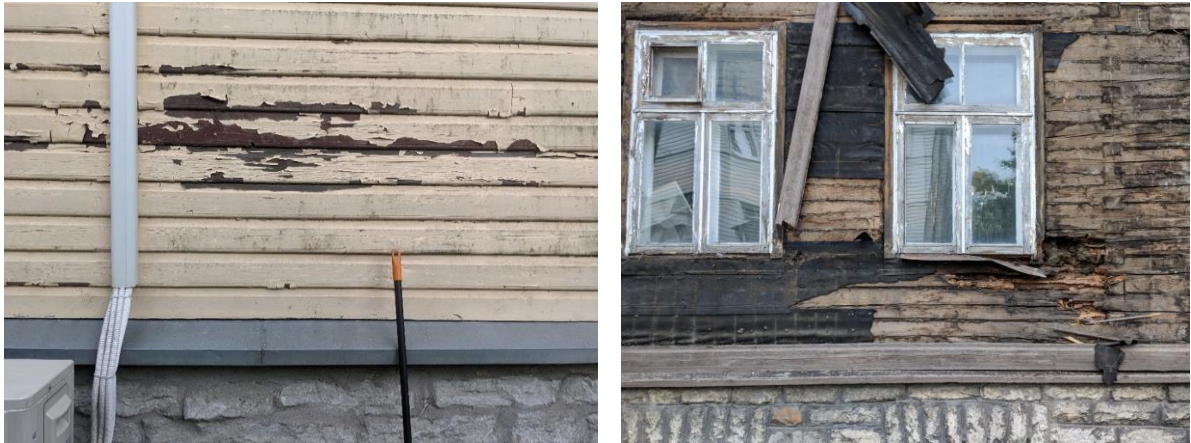
Figure 6-5: Condition of painted wooden cladding (left); damage to the load bearing structure due to faulty window flashing becomes visible after removal of the cladding (right). Photos: Paul Klõšeiko.

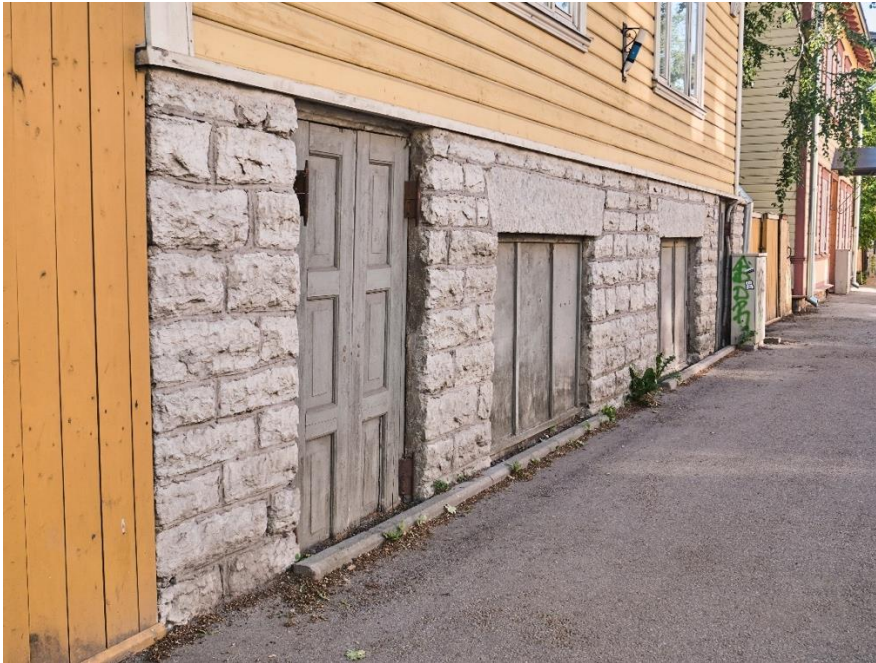
Figure 6-6: Limestone plinth area that has been submerged below the asphalt surface. An additional barrier made from kerbstones to prevent street surface runoff from entering the windows has proven to be insufficient. Photo: Paul Klõšeiko.

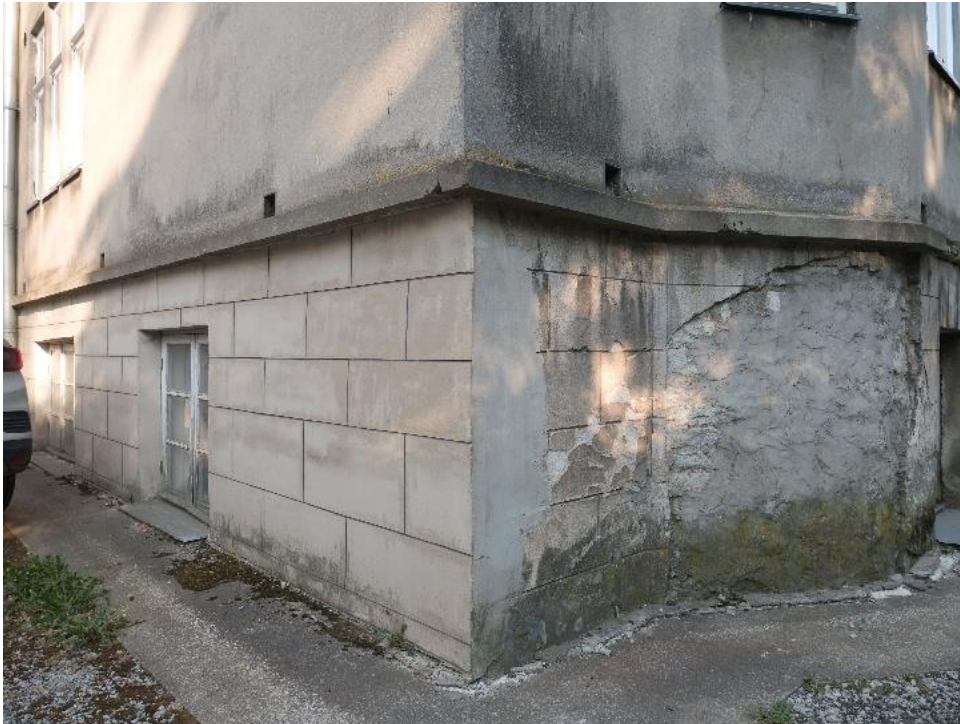
Figure 6-7: Signs of frost damage in the plinth area of a building that has log walls with ventilation cladding and plastered finish. On the right-hand side, the old plaster has delaminated from the limestone masonry. On the left-hand side, the plinth has been renovated, but early signs of deterioration are already visible in the lower section. Photo: Paul Klöšeiko.

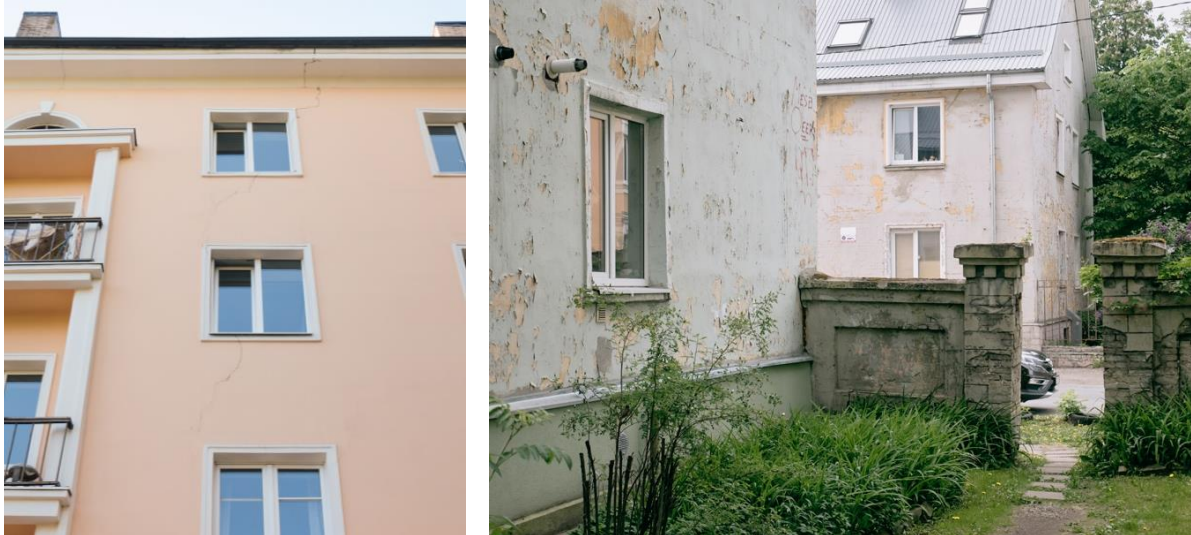
Figure 6-8: Cracks in the plastered mass masonry wall that have reappeared after replastering (left). Too vapour tight paint has started to peel off (right). Photos: Paul Klõšeiko.

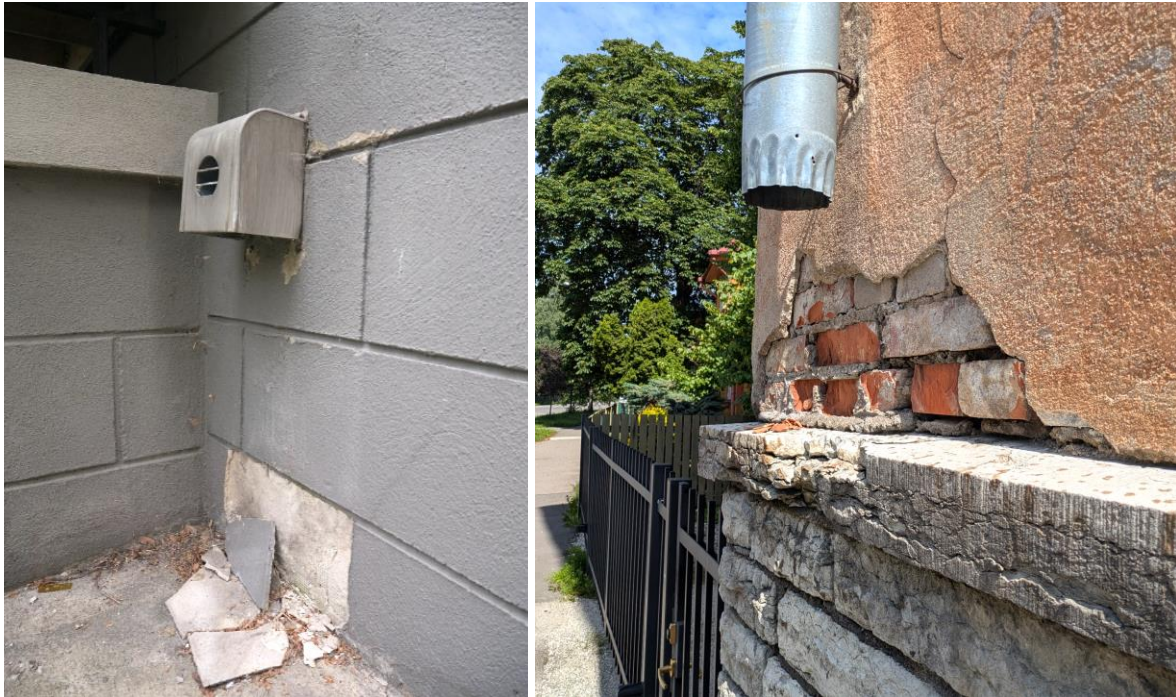
Figure 6-9: Left: lower section of the ETICS plinth, where plaster is in direct contact with the concrete strip cast against the plinth surface. Right: damage is commonly tied to faulty rainwater systems highlighting the importance of timely maintenance. Photos: Paul Klöšeko.

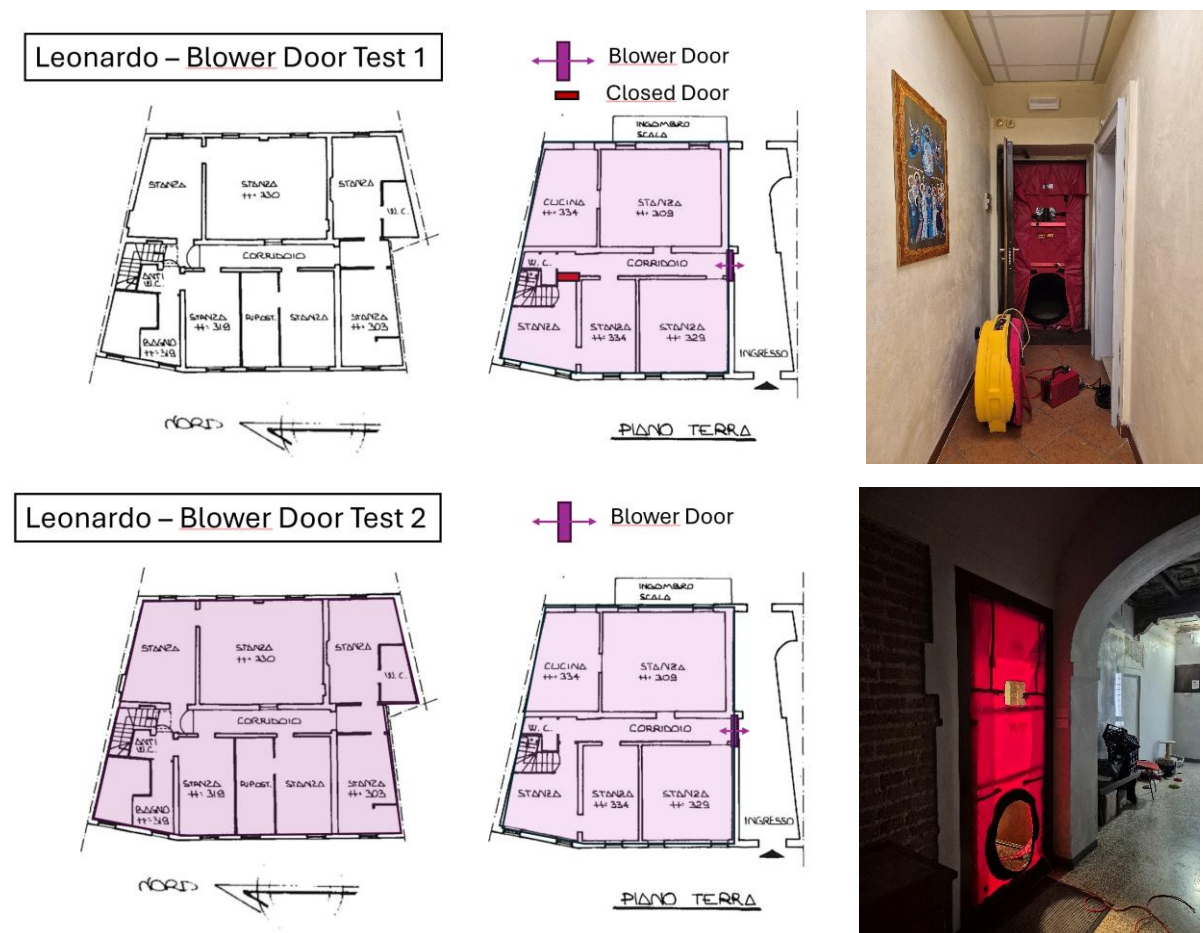
Figure 7-2: Blower Door test at *Leonardo*. First on ground level with door closed ( $n_{50}=3,9$  1/h) then on the overall building ( $n_{50}=4.7$  1/h).

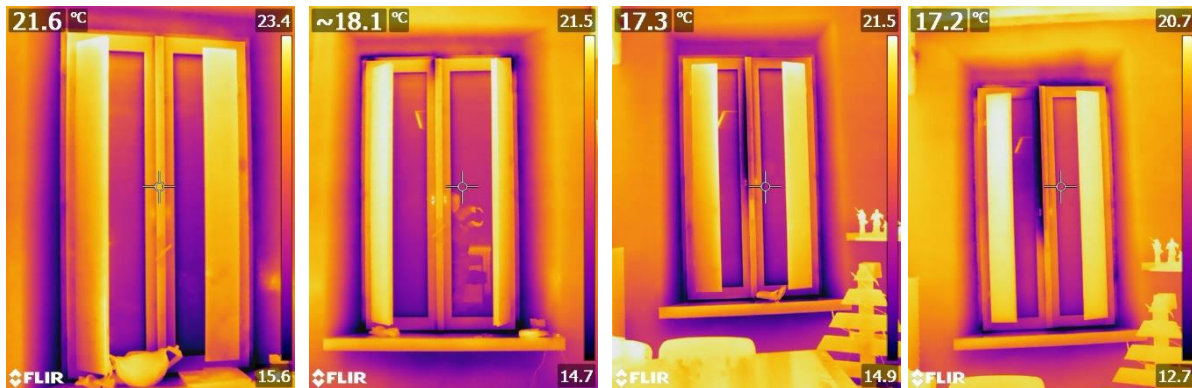
Figure 7-3: Thermography of the two windows in the dining room before and after the blower door test in depressurisation show air leakage.

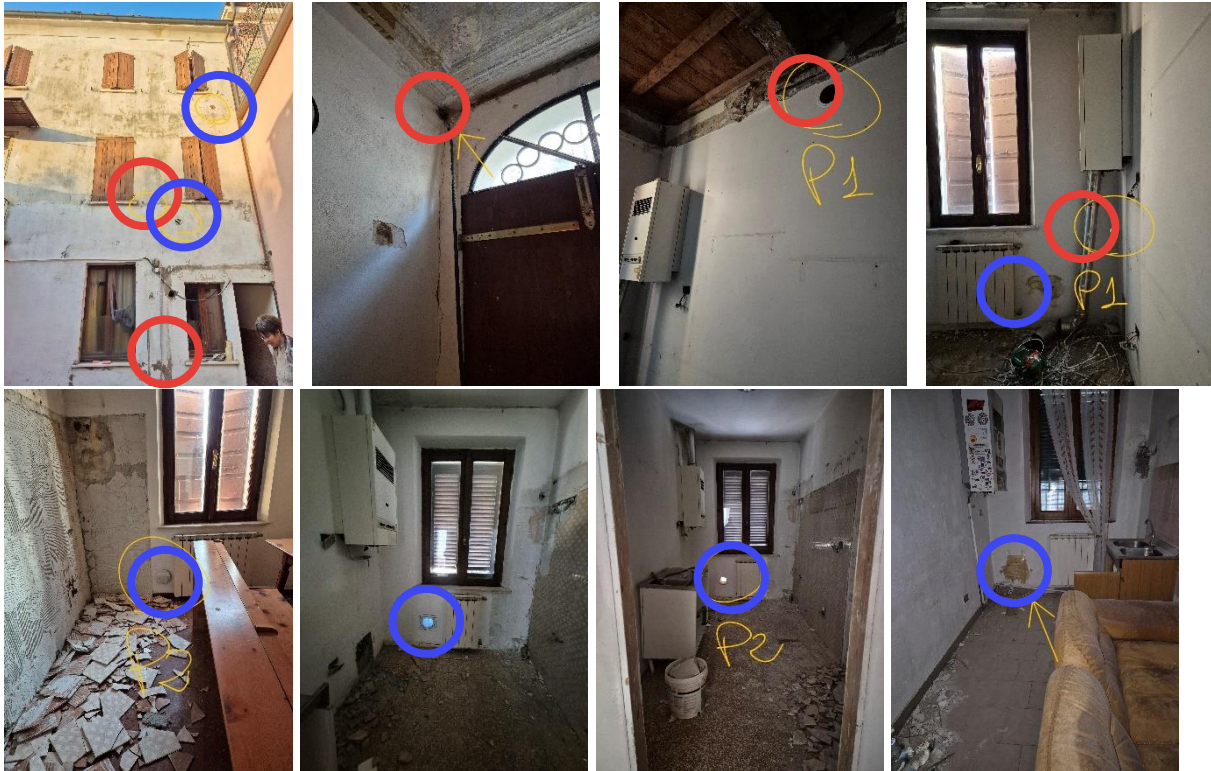
Figure 7-6: two kinds of leakage source sources at Montanara closed in step two (holes dur to building site - red), and step three (holes needed when gas boilers are present in the flat- blue).
