# HeriTACE

## Building envelope characteristics

Deliverable D2.1

| Project Title | Future-proofing Heritage Townhouses by Optimising Comfort and Energy in Time and Space |

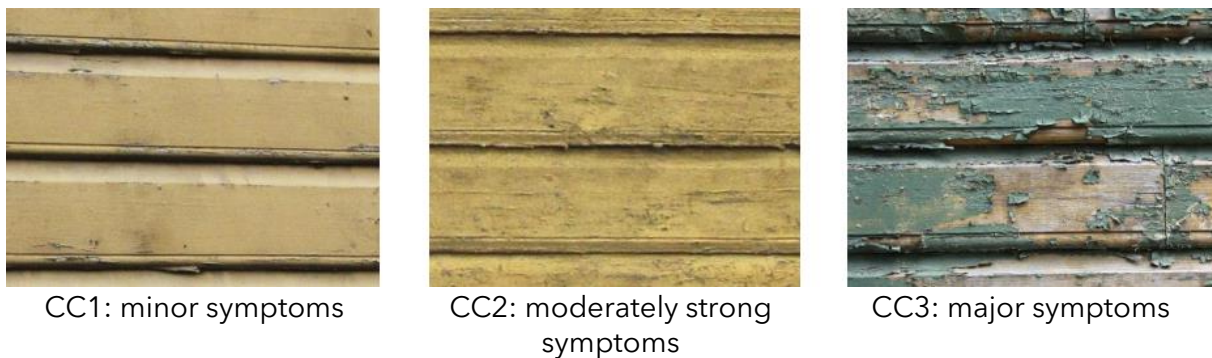
Figure 2-1: An example of condition classification of exterior paint.

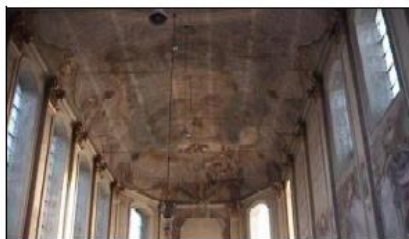
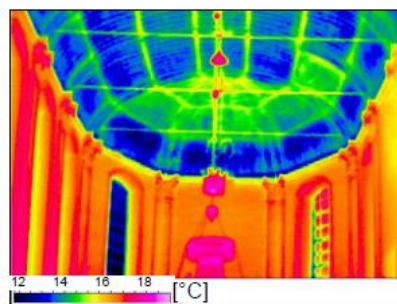
St. Gerlachus in Houthem, in [Schellen 2002]

Figure 3-9: More soiling on colder surface makes the otherwise hidden substructure visible

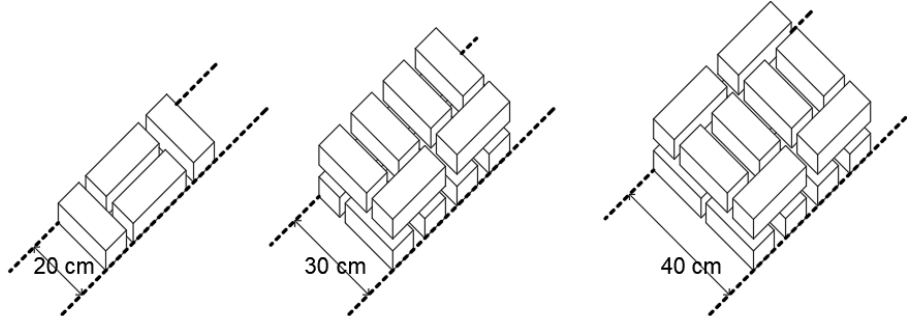
| <b>Typical condition</b> | <p>Typically RC0: good, may need maintenance in 10 years.</p> <p>Front facades are generally in good condition, largely because they are highly visible from the street and therefore receive regular maintenance and are often recently renovated. In contrast, rear facades and annexes typically receive much less attention, which can result in poorer overall condition. Structurally, however, all these walls remain sound, due in part to the durable nature of the solid masonry construction.</p> | | | | | |
| <b>Typical damage mechanisms</b> | <p>Common degradation mechanisms affecting solid brick masonry walls include salt efflorescence originating from the bricks, as well as flaking of plaster and/or paint layers on facades due to cyclical expansion and contraction, and solar exposure. In addition, plastered finishes may become dirty as a result of urban pollution.</p> <p>Mould growth and condensation on the interior surface are relatively rare, primarily due to the thickness of the solid masonry, which buffers temperature fluctuations from the outside. Furthermore, the lime plaster layer contributes additional moisture buffering capacity, contributing to the mitigation of mould growth. Damage as a consequence of freeze-thaw cycles is not observed but will be an important concern when insulating these masonry walls from the interior side.</p> | | | | | |

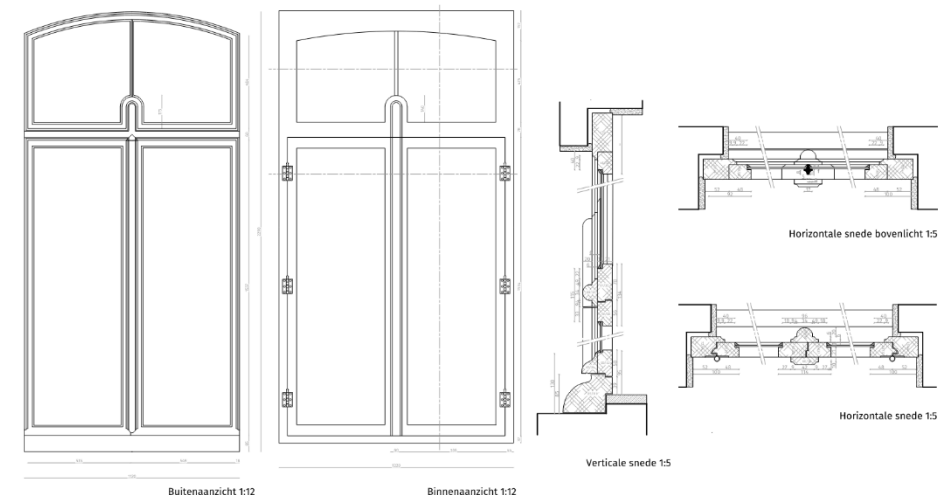
| <b>Typical damage mechanisms</b> | <p>Windows are typically among the most vulnerable building components in historic constructions. The thin wooden frames are particularly susceptible to wood rot and mould growth, especially at the lower sections where moisture tends to accumulate due to condensation on the single glazing. These slender frames are highly sensitive to external environmental conditions, such as freezing temperatures and fluctuating humidity levels. Consequently, the timber undergoes repeated cycles of swelling and shrinking, which can lead to cracking, warping, and general structural distortion over time.</p> |

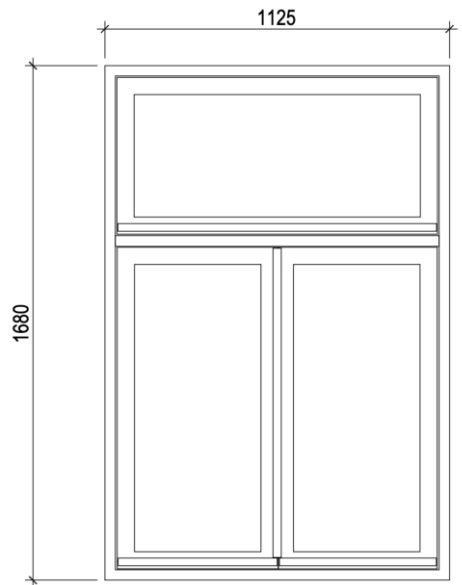
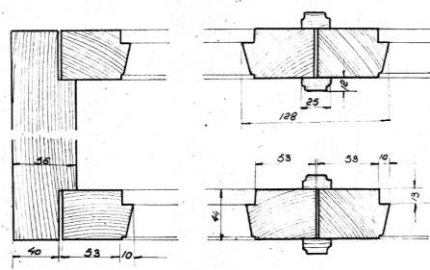
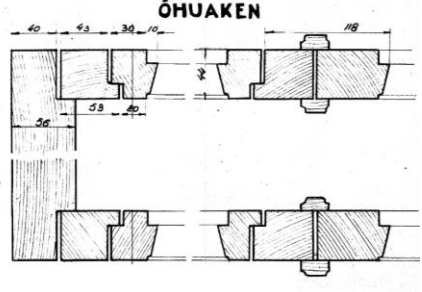
| <b>Typical condition</b> | The condition is largely dependent on maintenance. A sense of complacency, driven by the low upkeep of modern plastic windows, often leads to the neglect and swift deterioration of older, higher-maintenance wooden frames. |
| <b>Typical damage mechanisms</b> | UV and moisture cause strain on the paint layer which after cracking and peeling loses its protective capabilities. Rainwater penetration as well as condensation on the interior surface of the outer window causes swelling, cracking and decay of the wooden elements. |

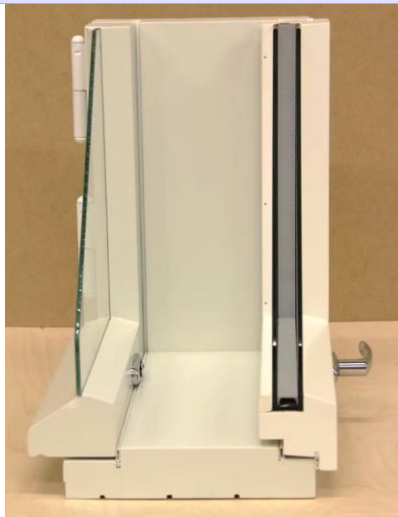
| <b>Typical condition</b> | As such retrofitted windows are rather new, their condition is generally good. Main issues concern the paint layer that may have started to age and when left unmaintained, damage will also propagate to wooden parts. Sealants also need regular checking and repairs as necessary. |
| <b>Typical damage mechanisms</b> | UV and moisture deformations cause strain on the paint layer which after cracking and peeling loses its protective capabilities. Rainwater penetration causes swelling, cracking and decay of the wooden elements of the window. |

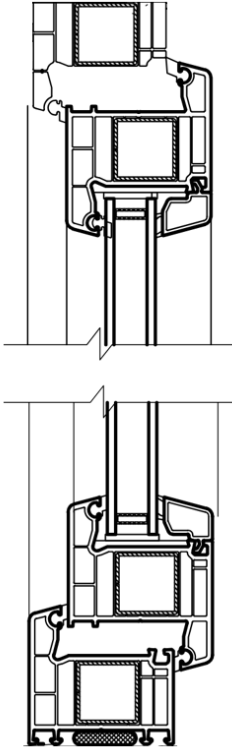
| <b>Typical condition</b> | As the windows are quite durable, the main technical issues concern deformations which cause loss of airtightness and difficulties with opening/closing. |
| <b>Typical damage mechanisms</b> | Thermal and creep deformations. Degradation of materials due to UV radiation and aging of polymers. |

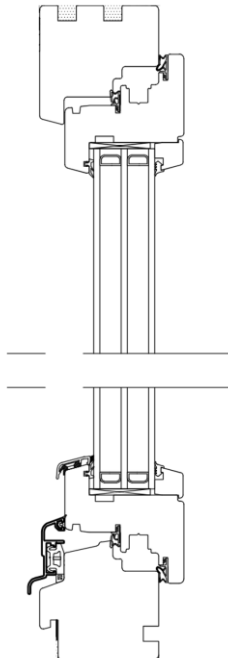
| <b>Typical condition</b> | <p>As such retrofitted windows are rather new, their condition is generally good. Main issues concern the paint layer that may have started to age and when left unmaintained, damage may also propagate to wooden parts. Sealants also need regular checking and repairs as necessary.</p> |
| <b>Typical damage mechanisms</b> | <p>UV and moisture cause strain on the paint layer which after cracking and peeling loses its protective capabilities. Rainwater penetration causes swelling, cracking and decay of the wooden elements of the window.</p> |

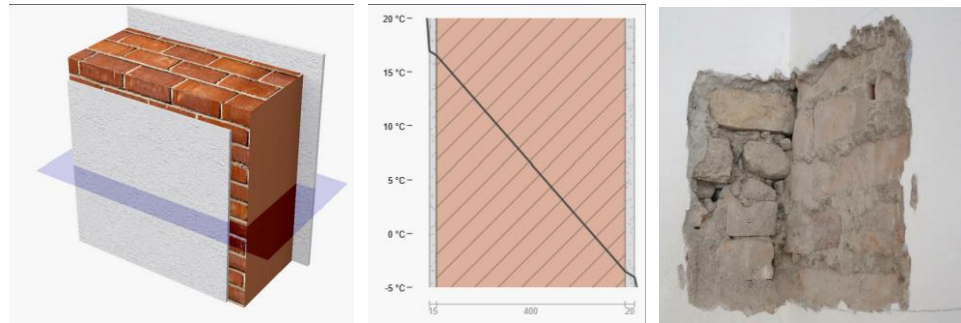
| <b>Typical damage mechanisms</b> | <p>Solid brick masonry walls can experience various degradation mechanisms, such as salt efflorescence from the bricks, flaking of plaster and paint layers on facades due to cyclical expansion and contraction, and solar exposure. Plastered finishes may also accumulate dirt from urban pollution.</p> <p>Mould growth on the interior surface is relatively rare, especially if the windows are still the original ones and respectively not air tight. In rooms with high humidity loads as e.g. bathrooms, mould growth might however be observed.</p> |

(left) sketch and calculation created with ubakus.de, (right) fragments of masonry visible under the plaster in *Romano*.

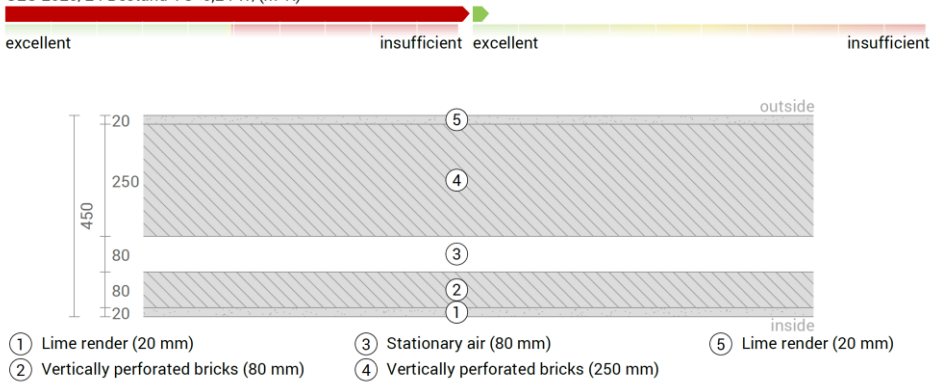
| <b>Typical condition</b> | RC1. Condition is usually good, just maintenance of plaster needed. | | | | |

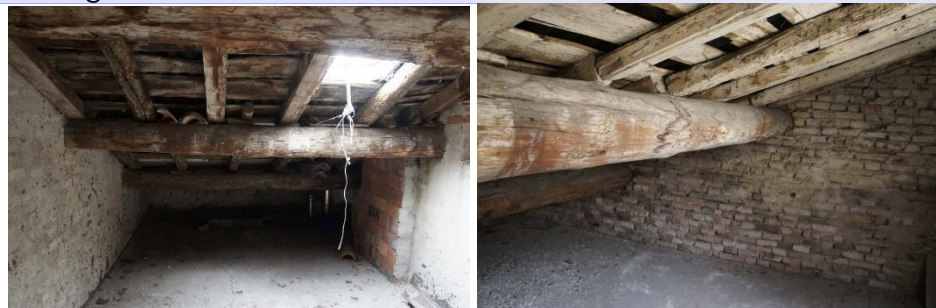
| <b>Typical damage mechanisms</b> | There is an inherent risk of wood rot, however this has not been observed in the case study buildings. Rainwater entering in heavy storm events leaves traces on the wooden structure, but since the attics are not used and well-ventilated a fast drying usually prevents major damage. |

Roof construction seen from the attic - *Montanara* on the left, *Romano* on the right

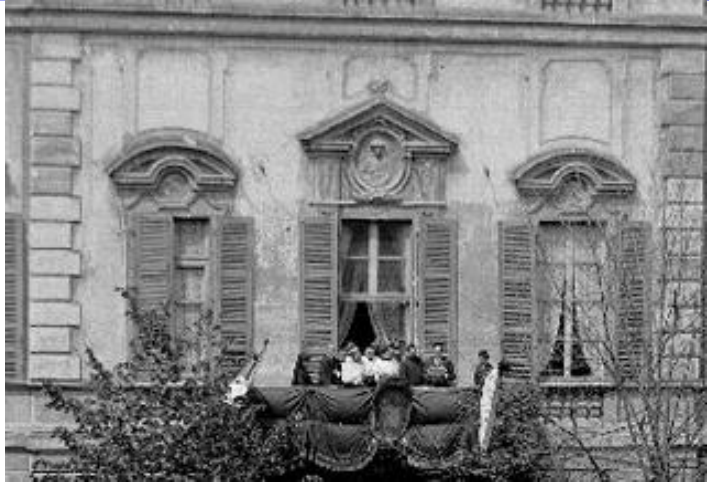
| <b>Typical condition</b> | RC 0 - RC 3: vulnerable component. It can be in good condition, if maintained with care (paint layer), more often it shows deformation, flaking of paint layers |
| <b>Typical damage mechanisms</b> | Shrinking and swelling of wooden parts lead to deformation and loosening of connections, but also to cracks in the paint via which humidity can enter. Outside moisture from driving rain, inside moisture from condensation on single glazing. |

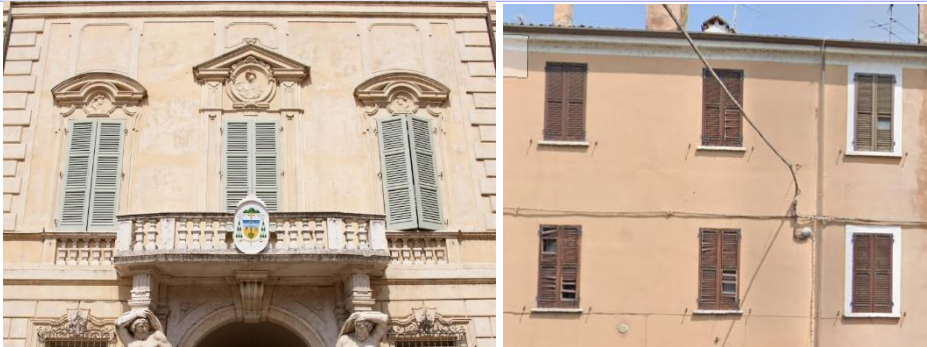
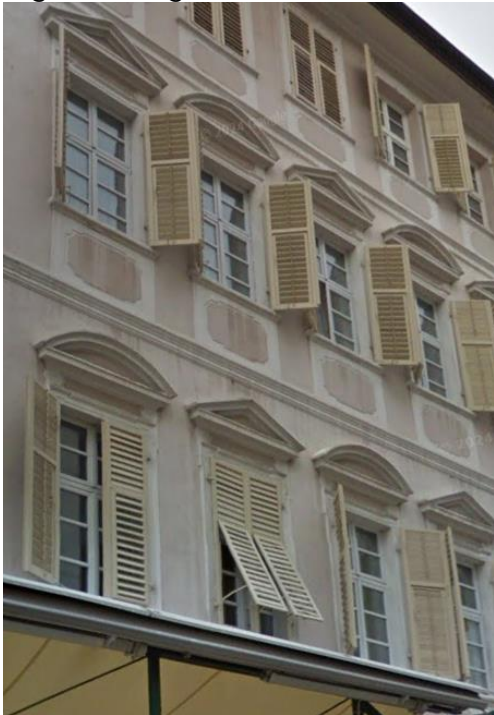
| <b>Typical condition</b> | Wooden shutters need regular care of the paint layer. If this is not done, the cracking paint allows water to enter the wooden parts, which leads to deformation and loosening of slats |
| <b>Typical damage mechanisms</b> | UV, Fainting and flaking of paint layer, deformation |
| <b>Illustration</b> | <p>(left) Vescovile David Tomaszewski, Aug 2019, <a href="https://maps.app.goo.gl/M25ZiKRyhjHg52x9">https://maps.app.goo.gl/M25ZiKRyhjHg52x9</a><br/> (right) damaged shutters in Via Trento, Mantova</p> <p>Shutters with tiltable slats and lower part openable</p> |

The wooden shutters will usually have suffered from shrinking and swelling with changing temperatures and humidity: connections might have loosened, slats fallen out (see photo 7.1.4.4), and the paint will be flaking off. This can however be well repaired and also kept to a minimum with regular care. If the shutters have already been changed to PVC shutters, damages as discolouring due to UV and material degradation like getting brittle are more difficult to counteract and prevent.

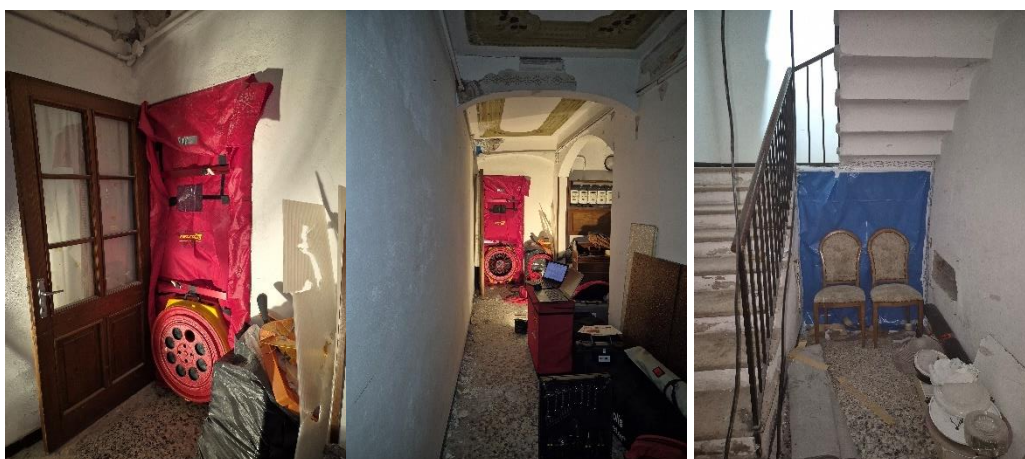
Figure 7-4: Installation of the Blower Door at *Montanara* (left and middle) and sealing towards the cellar (right)

At *Montanara* the Blower Door test was done during a running construction site. This means, that the results might not depict directly the use phase, but it allowed on the other hand site to do the test in several steps – closing one “leakage source type” after the other. The Blower Door test was done on the whole building excluding the cellar, i.e. the base variant was already done, sealing the opening towards the cellar (see Figure 7-4). That this sealing was difficult to archive under construction site conditions adds uncertainty to the measurements – it had to re-seal several times, but the operators observed the situation closely.

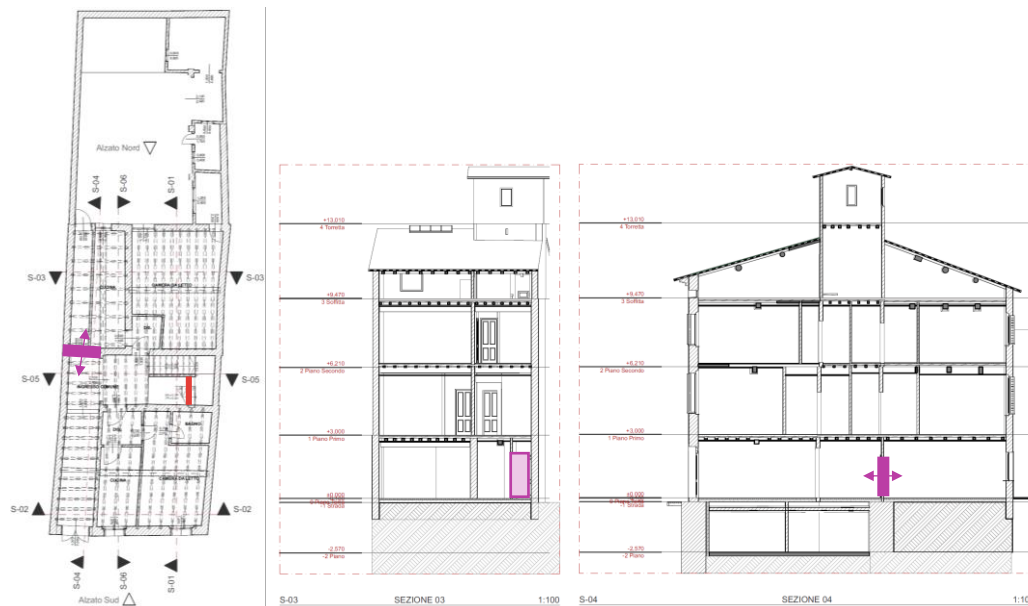
Figure 7-5: position of blower door and sealing of opening towards the cellar at *Montanara*.

The first test was done both under depressurisation and pressurisation. Since the test under pressurisation brought a large amount of dirt from the courtyard and corridor into the buildings, it was not repeated in the following steps. The second step was **closing all obvious holes** due to the construction site (open holes for dismantled flue chimneys). This resulted in an  **$n_{50}=6.16$  1/h**.

In step 3 the **ventilation openings** which any Italian appartement needs to have if a **gas heater** is present. This results in an  **$n_{50}=5.83$  1/h** reducing the  $n_{50}$  value by 0,3 1/h or rather the effective leakage area  $ELA_{50}$  by  **$\Delta ELA_{50}=100$  cm<sup>2</sup>** to 1780 cm<sup>2</sup>.

In step 4 the visibly leaky door from the ground floor appartement to the backyard was sealed all around, resulting in an  **$n_{50}=5.41$  1/h** reducing the  $n_{50}$  value by 0,42 1/h or rather the effective leakage area  $ELA_{50}$  by  **$\Delta ELA_{50}=130$  cm<sup>2</sup>** to 1650 cm<sup>2</sup>.

In step 5 the ancient main front door was sealed all around, resulting in an  **$n_{50}=5.14$  1/h** reducing the  $n_{50}$  value by 0,27 1/h or rather the effective leakage area  $ELA_{50}$  by  **$\Delta ELA_{50}=80$  cm<sup>2</sup>** to 1580 cm<sup>2</sup>.

Also, in the case of *Montanara* the windows were fairly new ones. The still quite high  $n_{50}$  value of the last step is most probably due to considerable leaks towards the attic and through the glazed upper closer of the staircase.

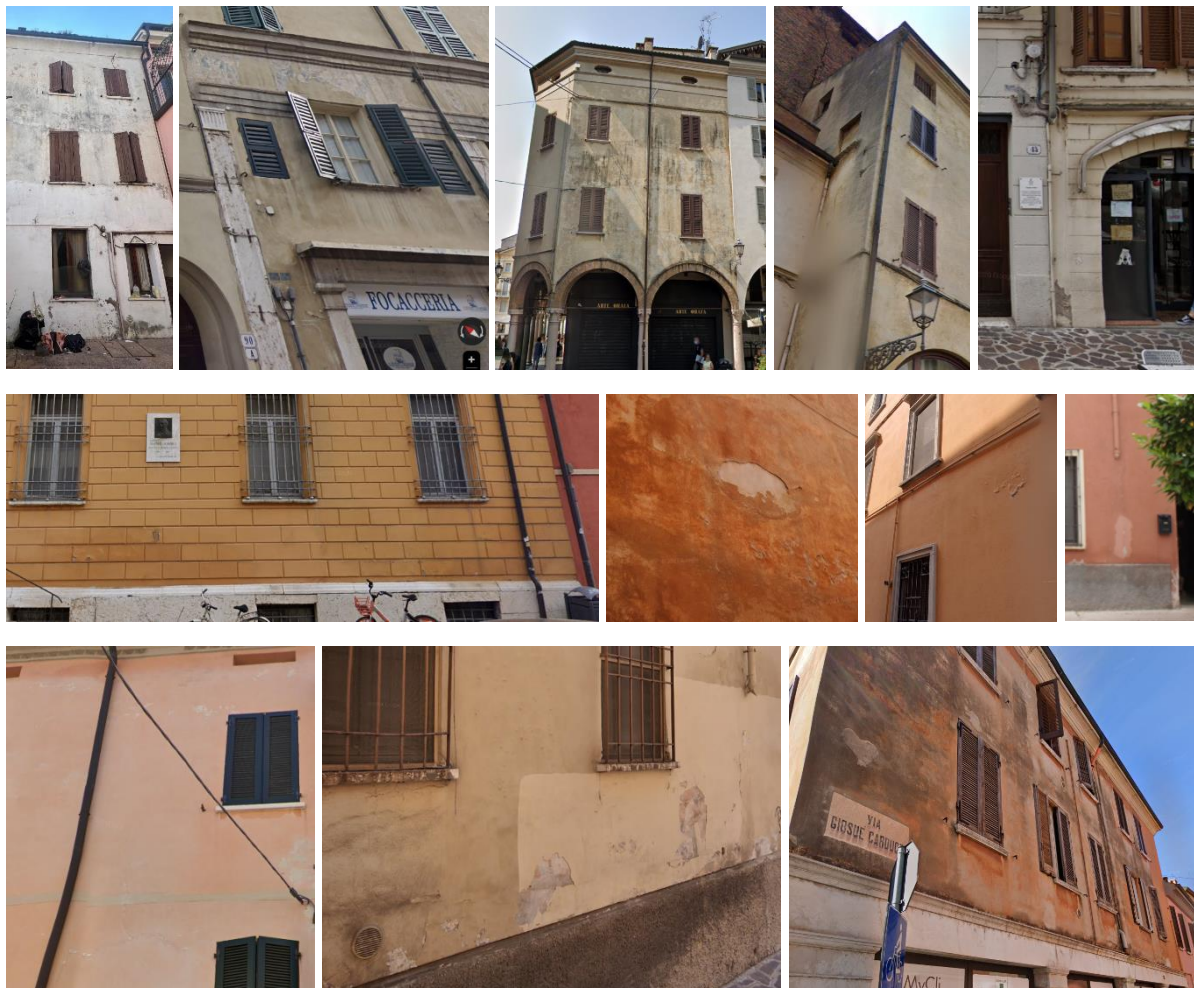
Figure 7-7 Façade photos from HeriTACE case studies and other buildings in Mantova.

The plaster finish on the exterior might show soiling and also points of humidity, particularly on the back and secondary facades. This can be due to leaky rain gutters in drains, but also to local differences of water uptake with driving rain (due to cracks but not only) and protection from driving rain. Detachment of the upper paint or even plaster layers can also be observed, it is however not too frequent. In the lower parts salt efflorescence and powdering of plaster and/or stone. Where the exterior plaster has already been replaced, it usually shows less damage, would however, from heritage point of view be easier to be replaced with a more energy efficient solution as e.g. insulating plaster.

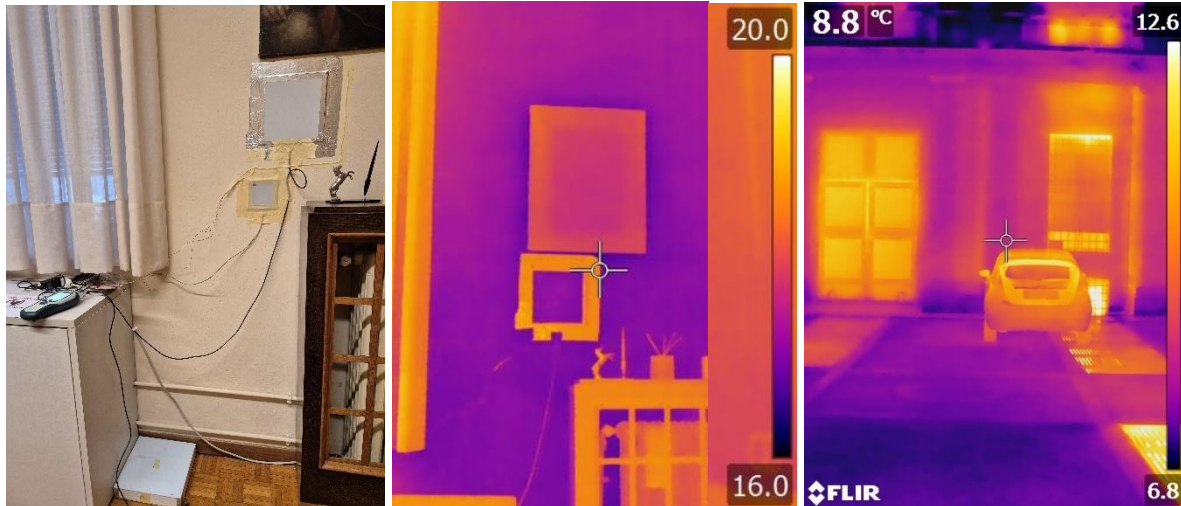
Figure 7-9: U-value measurement at Vescovile. Installation and IR image inside and outside.

In two case study buildings the actual thermal performance of the wall has been measured (according to the method described in 2.3.1). In *Vescovile* a wall on the ground floor towards the courtyard building has been chosen. The measured U-value results in  $U=0.85 \text{ W/m}^2\text{K}$ . Considering a thickness of 70 cm of the wall, this corresponds to an average thermal conductivity  $\lambda=0.7 \text{ W/mK}$ , which is in correspondence with the value of  $0.72 \text{ W/mK}$  given in UNI/TR 11552:2014 for MLP01 Muratura in mattoni pieni. The measurement at *Leonardo* lead to a value of  $U=0.81 \text{ W/m}^2\text{K}$ , which for a thickness of 44 cm corresponds to a much lower average thermal conductivity  $\lambda=0.42 \text{ W/mK}$ . Research in different material databases,

as e.g. the one in [www.ubakus.de](http://www.ubakus.de) would give a  $\lambda=0.47$  W/mK for a density  $\rho=1200$  kg/m<sup>3</sup>. It seems just reasonable that there is a considerable variety for thermal conductivity. In 7.1.1, both these values have been reported, the proposed U-values of 0.8 to 0.9 W/m<sup>2</sup>K for the front wall correspond finally to both measured value and take into account that thicker walls of larger buildings might have been built with higher density bricks. The U-value of 1.0 to 1.2 for the backyard wall has been determined based on the lower  $\lambda=0.47$  W/mK applied to the usually thinner backyard walls (32-36cm instead of 40-44cm).

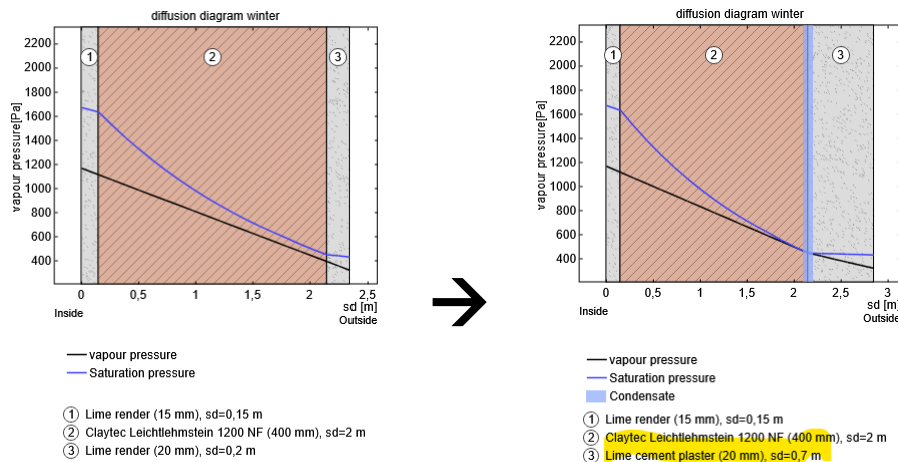
Option two for the masonry wall differs just in the assumption that the exterior plaster has been changed to a cement-based plaster. This would not influence the thermal performance but rather the hygrothermal situation, since the cement plaster has higher vapour resistance. This does result in a situation where condensation can occur at the interface from masonry wall to lime cement plaster, as Figure 7-11 shows. The calculation confirms however that there is sufficient drying reserve (DIN 68800-2), or rather the drying time according to DIN 4108-3 is with 14 days clearly below the limit of 90 days.

The higher vapour resistance might still lead to the shift of the drying horizon for rising damp and thus the shift of potential damage to other, higher areas.

Figure 7-11: Diagram showing the vapour pressure gradient in a masonry wall with lime plaster (left) and lime cement plaster (right) over the cumulative sd-value on the x-axis.
